# The 2023 $M_w$ 6.8 Al Haouz, Morocco earthquake: A multi-layer reconnaissance framework for the remote sensing and field assessment of landslides, building and heritage damage, and road access disruption in the High Atlas region

presents findings from the Earthquake Engineering Field Investigation Team (EEFIT) mission. Different radar and optical remote sensing techniques were used to identify areas most affected by earthquake-induced landslides and building damage, guiding the field investigations. A total of 2671 earthquake-induced landslides were identified; although relatively limited for an event of this magnitude, they significantly impacted road accessibility and emergency response. In parallel, 455 buildings were assessed on site and classified using the EMS-98 scale. Seismic performance was primarily influenced by construction practices and detailing rather than structural typology. Traditional unreinforced masonry buildings exhibited the highest vulnerability, largely due to substandard materials and construction practices, and limited upkeep, which are common in remote villages. Hybrid constructions combining traditional and modern techniques also performed poorly. Co

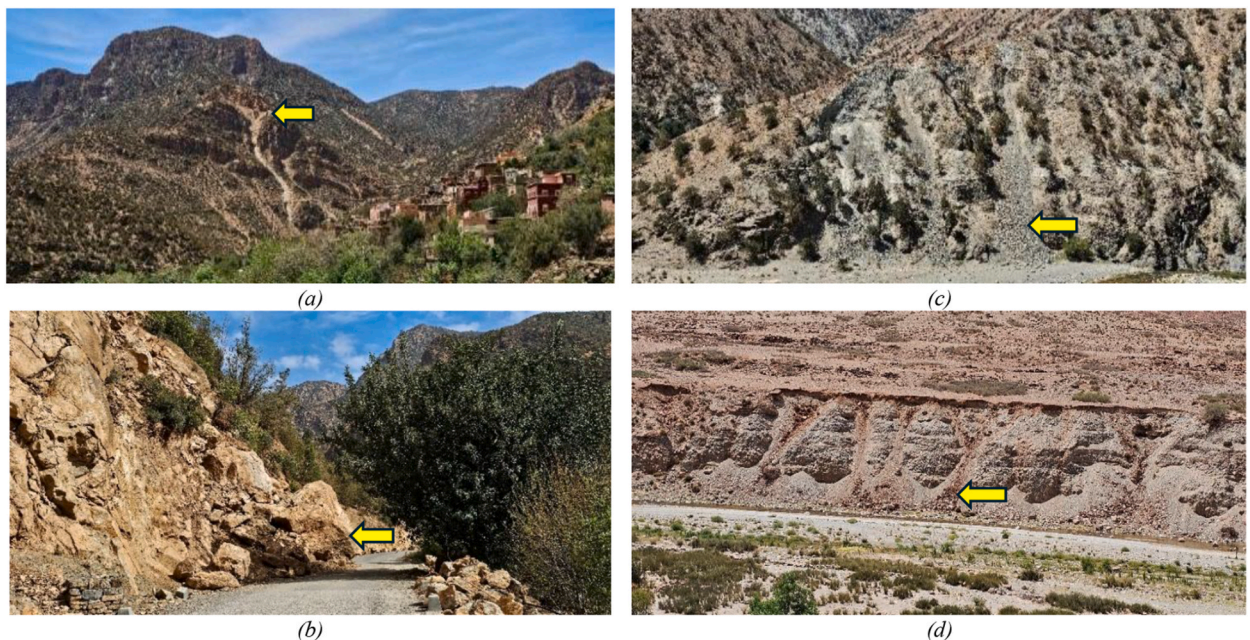
**Fig. 7.** Earthquake landslide field examples. (a) Mesozoic limestone rockfall with long runout; (b) Mesozoic limestone debris partially blocking the road; (c) Palaeozoic schist rockfalls/slides and soil slide debris runouts; (d) Soil slide failures of Quaternary River terrace sediments.

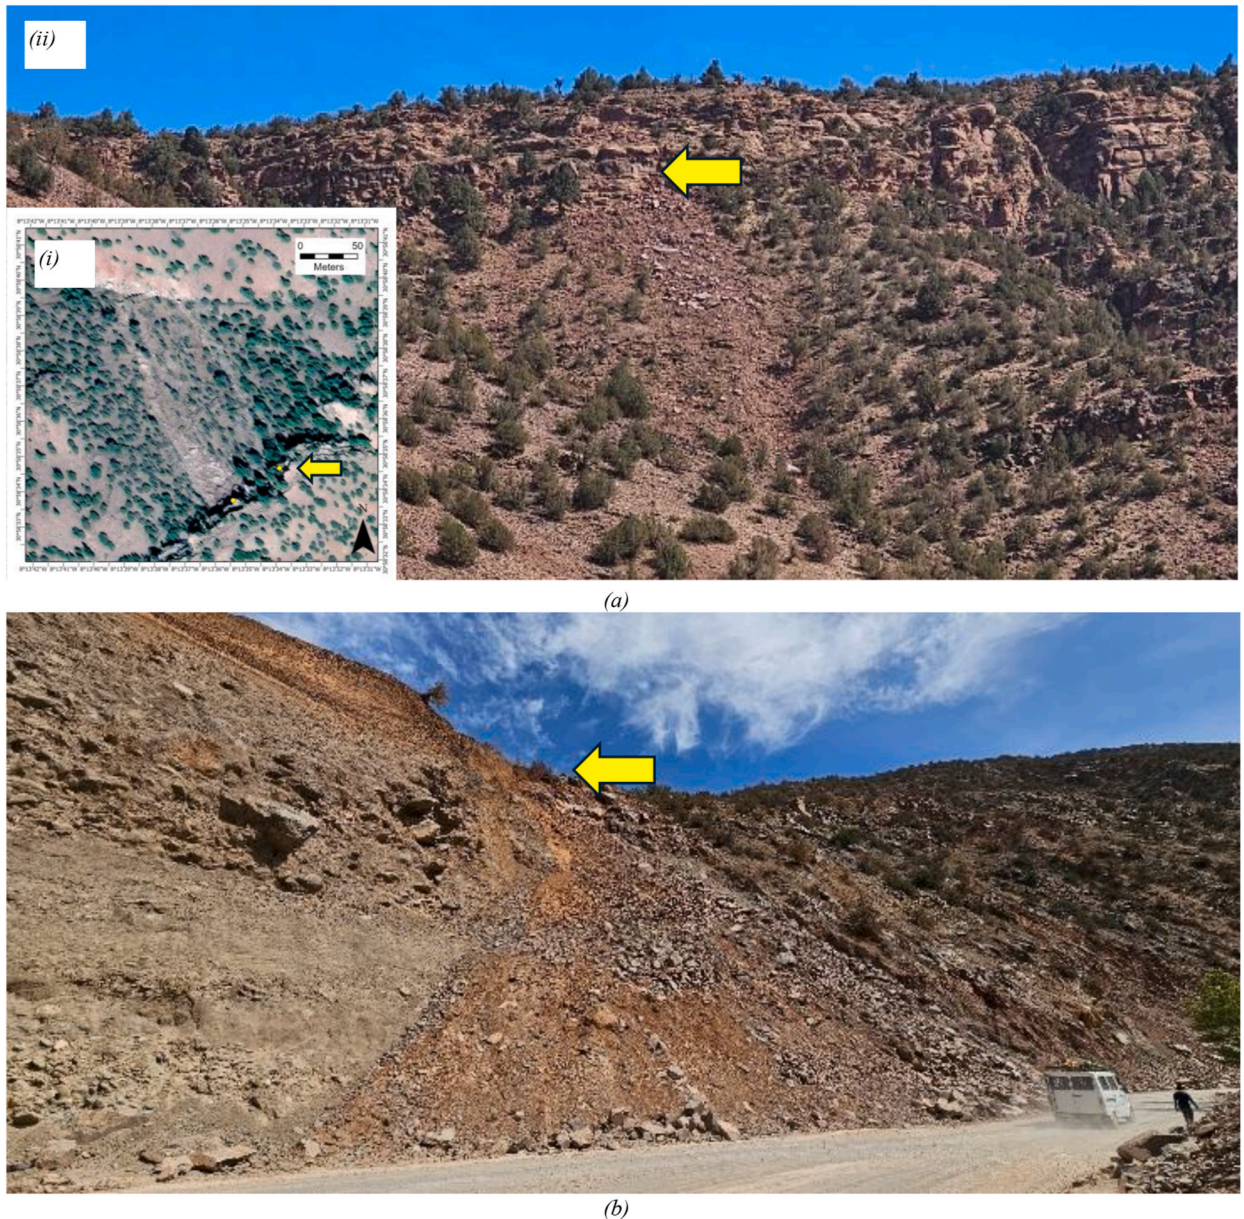
**Fig. 8.** (a) Mesozoic sandstone rockfall initiated from the ridgeline cliff: (i) Maxar satellite image; (ii) Field image, and (b) R202/N7 road widening near Imgdal village, with failure of Palaeozoic schist and Quaternary soil cut slope, resulting in road blockage and clearing. The failure has reactivated multiple times since the initial failure and clearing.

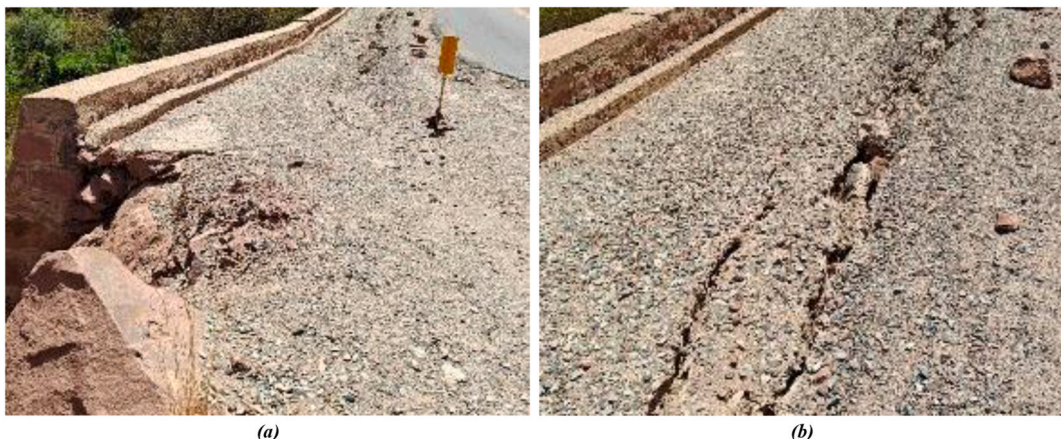
Fig. 9. Tension cracks and damage to small retaining structures along the R202/N7.

caused by landslide and rockfall impacts (Fig. 9).

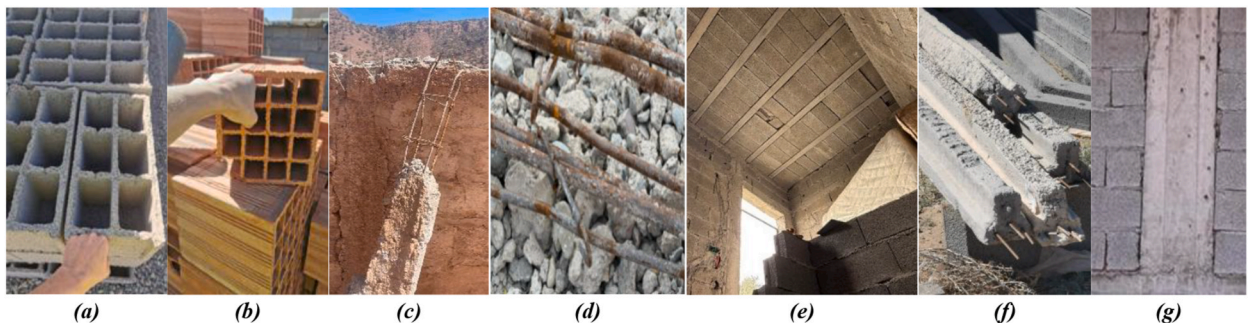
**Fig. 13.** (a) Concrete Masonry Units (CMUs) with large voids and insufficient web thickness; (b) hollow clay bricks with large voids and insufficient web thickness; (c) poor reinforcement in the Reinforced Concrete (RC) tie-elements (d) debris showing poor-quality concrete and smooth reinforcement bars used for the RC elements; (e) Confined Masonry (CM) panels and floor system composed of RC joists and CMU infills; (f) typical RC joists used in CM floor construction; (g) lack of tothing between masonry walls and RC tie-columns.

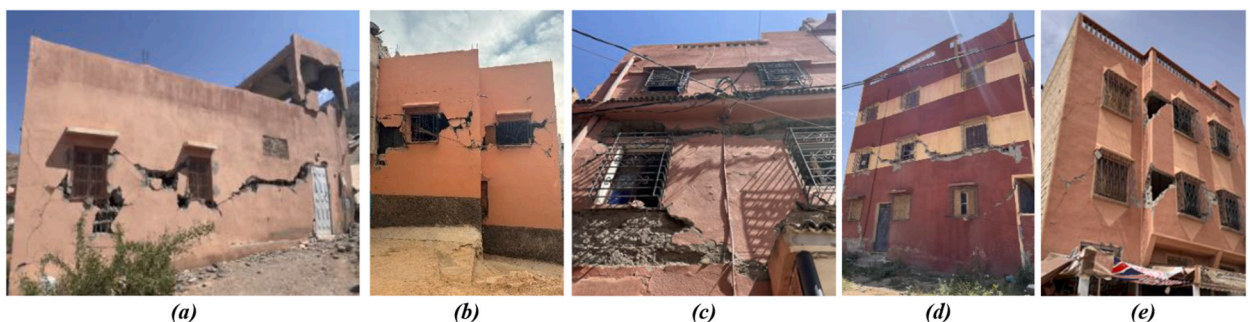
**Fig. 14.** Confined Masonry (CM) buildings showing (a–c) X-shaped and diagonal shear cracks, with localised crushing and spalling of Concrete Masonry Units (CMUs) associated with poor masonry quality; (d) vertical irregularity; and (e) plan irregularity.

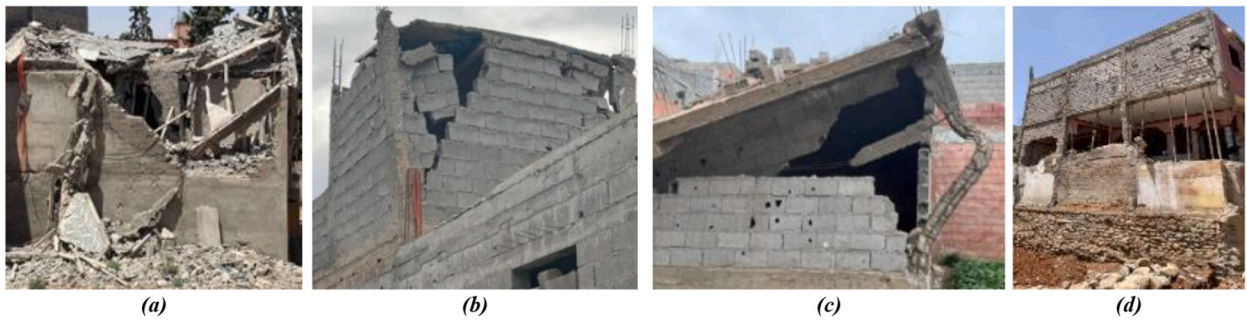
**Fig. 15.** Confined Masonry (CM) buildings showing roof failure driven by: (a–b) overturning of panels; and failures at beam–wall (c) and column–wall interfaces. CM building showing (d) panel dislodgement and material loss in columns with exposed reinforcement.

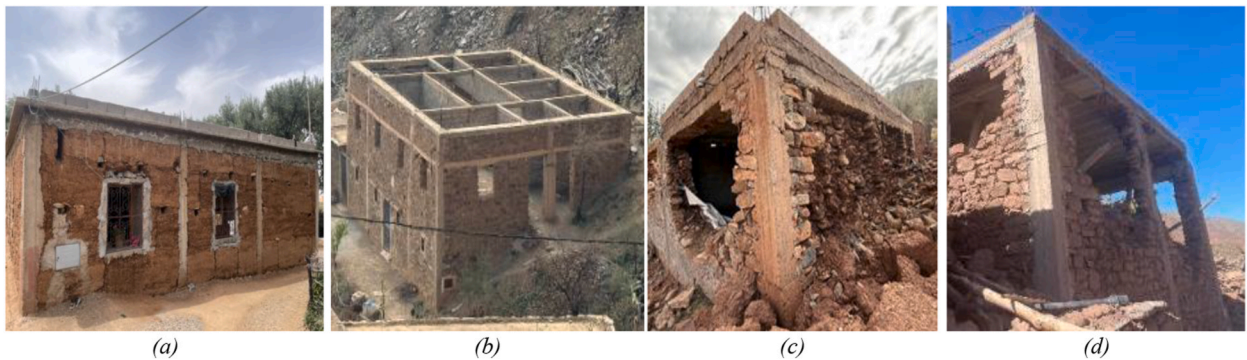
In the buildings shown in Fig. 16a and b, the RE and SM walls may have been constructed before the RC tie-elements were cast.

**Fig. 16.** (a) Hybrid frame-wall system comprising RC framing combined with rammed earth (RE); (b) hybrid frame-wall system comprising RC framing combined with stone masonry (SM); (c–d) hybrid frame-wall system comprising RC framing with stone masonry (SM) wall panels exhibiting characteristic arch-shaped cracking.

By contrast, the buildings shown in Fig. 16c and d exhibit relatively large RC members forming a continuous structural framework around the SM walls. Although the original construction sequence cannot be established from post-earthquake reconnaissance alone, the observed structural configuration and damage patterns indicate that the masonry walls and RC elements did not develop the composite action expected in conventional CM. Furthermore, the thick traditional stone masonry walls cannot be assumed to function solely as non-structural infill, distinguishing these buildings from conventional RC frame buildings with masonry infill. This interpretation is supported by the extensive damage observed within the stone masonry, including arch-shaped cracking, dislodgement of masonry units and, in multi-leaf SM, separation of the external leaf (Section 5.3.2). These damage mechanisms are consistent with frame–wall interaction rather than the integrated behaviour expected in conventional CM. Consequently, these buildings did not

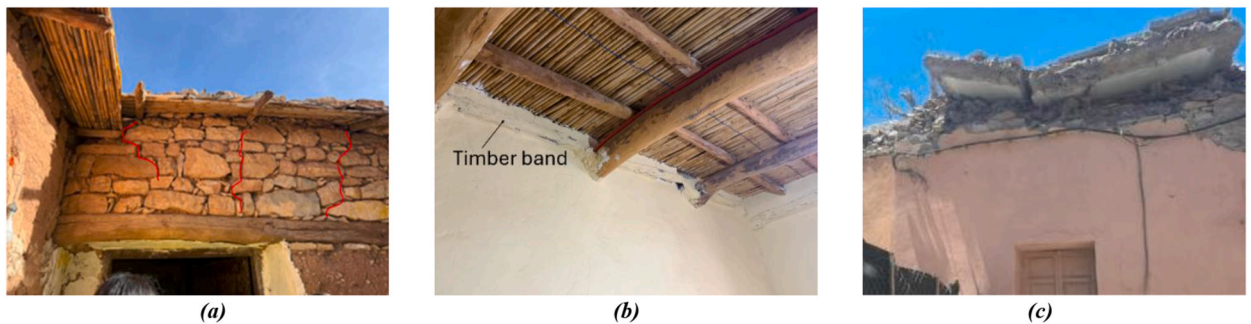
**Fig. 20.** (a) Vertical cracking due to reduced load transfer; (b) timber band below the roof; (c) RC slab replacing the original timber roof.

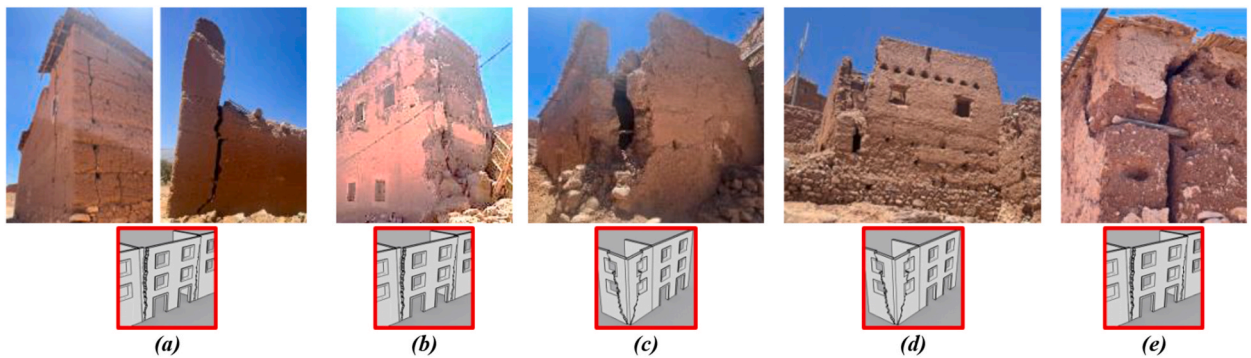
**Fig. 21.** RE buildings showing (a) severe vertical cracking along block joints; (b) out-of-plane failure; (c–d) corner failures; (e) smooth timber ties at the corner. Failure mode sketches adapted from Ref. [94].

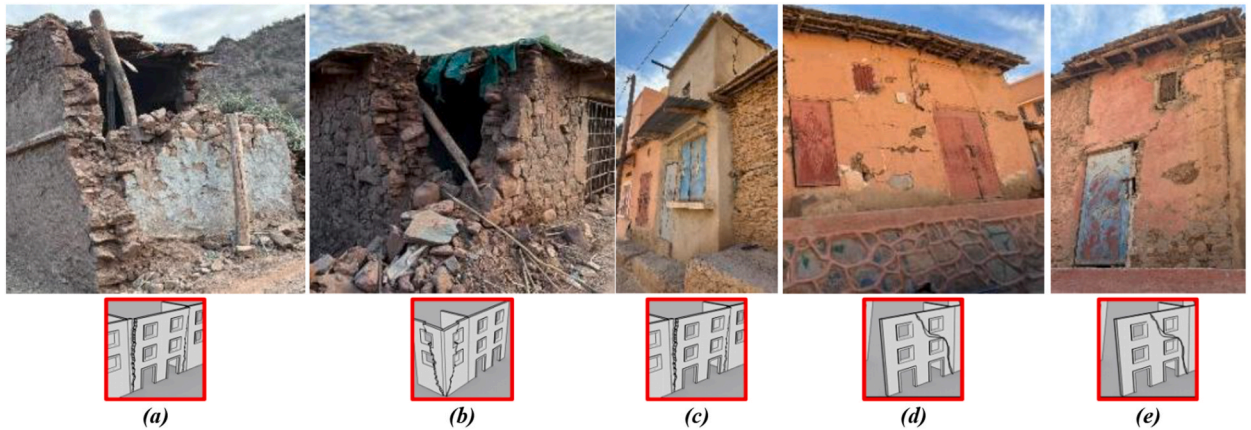
**Fig. 22.** SM buildings: isolated configurations with (a) out-of-plane failure and (b) corner failure; clustered configurations with (c) out-of-plane failure, (d) in-plane failure, and (e) pounding between adjacent buildings. Failure mode sketches adapted from Ref. [94].

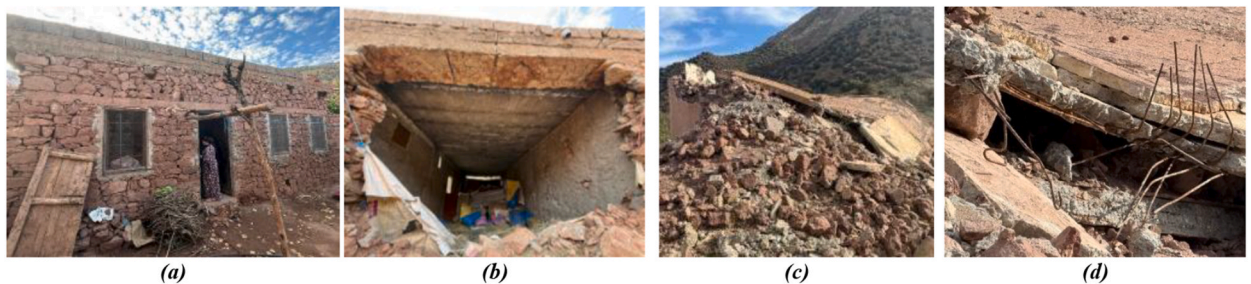
**Fig. 24.** (a) SM building with RC beams at lintel and roof levels; (b) out-of-plane wall dislodgement from the RC beam; (c) RC roof collapse; (d) failure of a lightly reinforced RC slab.

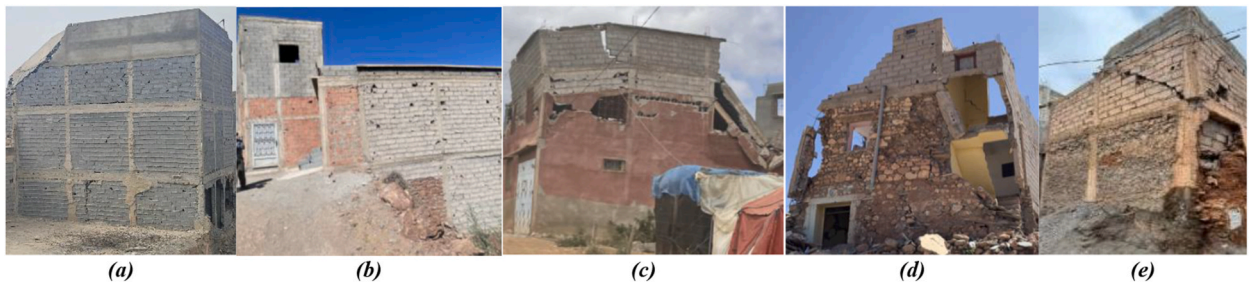
Fig. 26. Permanent housing: (a) without finishes, (b) with partial finishes, (c–e) observed failures of hybrid buildings.

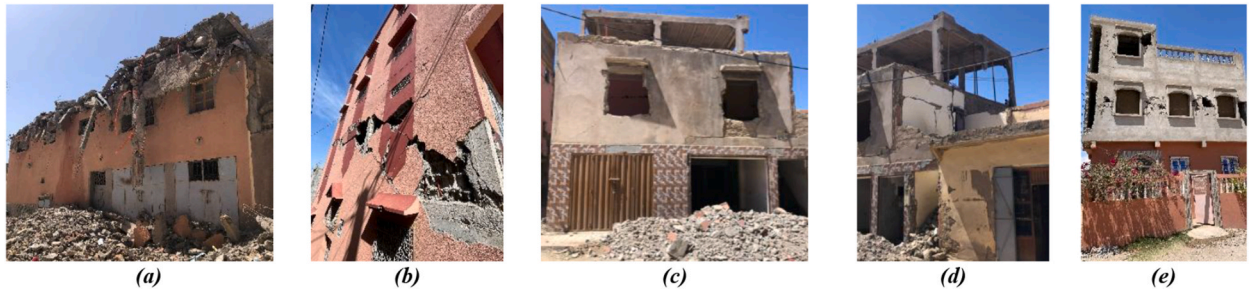
Fig. 27. Reinforced concrete (RC) buildings in settlements close to the epicentre: (a) failure of upper storey; (b) shear cracking in infill walls; (c–e) dislodgement and loss of infill panels.

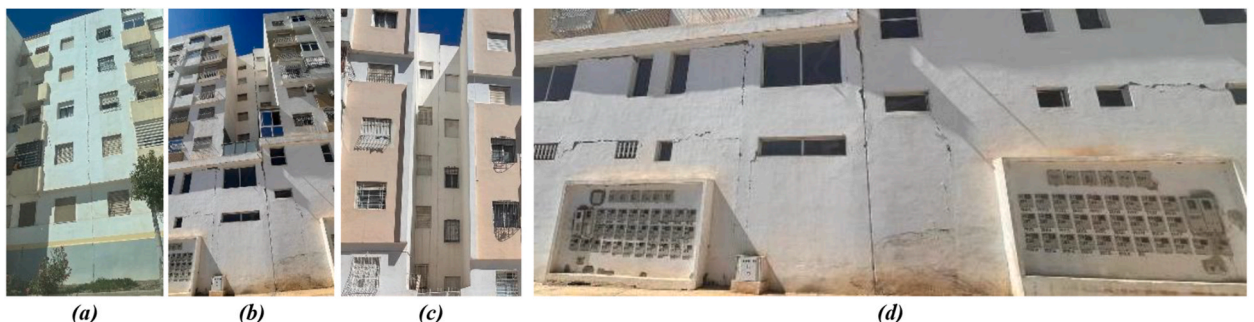
Fig. 28. Reinforced concrete (RC) buildings in Agadir: (a–c) Cracking observed at seismic joints; (d) Light damage to non-structural elements.

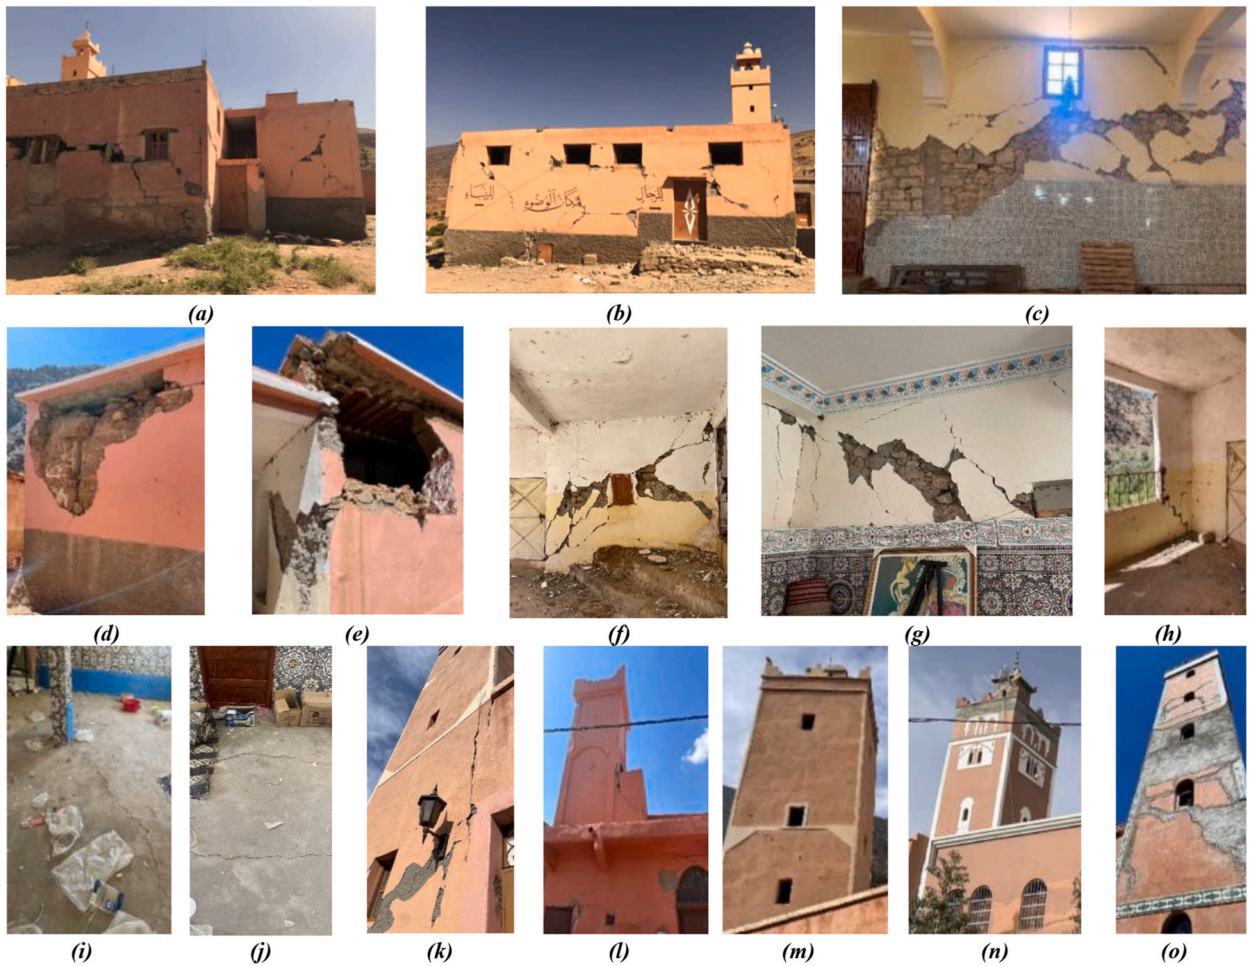
**Fig. 30.** CM mosques with CMU infill panels showing: (a–b) severe diagonal and X-shaped widespread shear cracking and partial collapse of infill panels; CM mosques with SM infill panels showing: (c) diagonal and horizontal infill separation cracks along with plaster detachment, indicating poor frame–infill interaction; URM mosques with RE and SM showing: (d–e) partial collapse of external walls, (f–g) diagonal shear cracking of internal walls, (h) opening corner cracks, (i–j) floor cracks; Minarets showing: (k) pounding damage; (l) partial collapse of unreinforced upper parapets; (m) diagonal shear cracking of infill panels; (n–o) repair interventions.

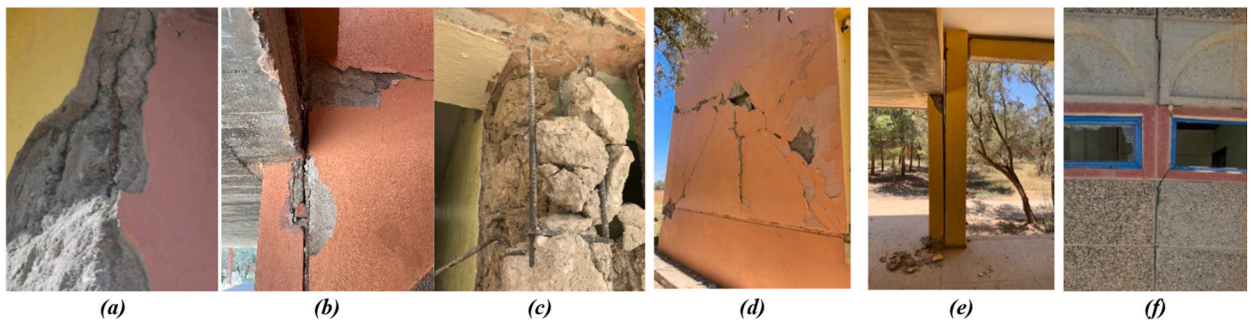
**Fig. 31.** (a) Concrete spalling; (b) separation between infill panel and RC frame; (c) possible column hinges with insufficient reinforcement confinement; (d) shear cracking and CMU block loss in infill panels; (e) residual drift in adjacent RC framed structures; (f) prefabricated concrete classroom showing panel separation and localised damage.

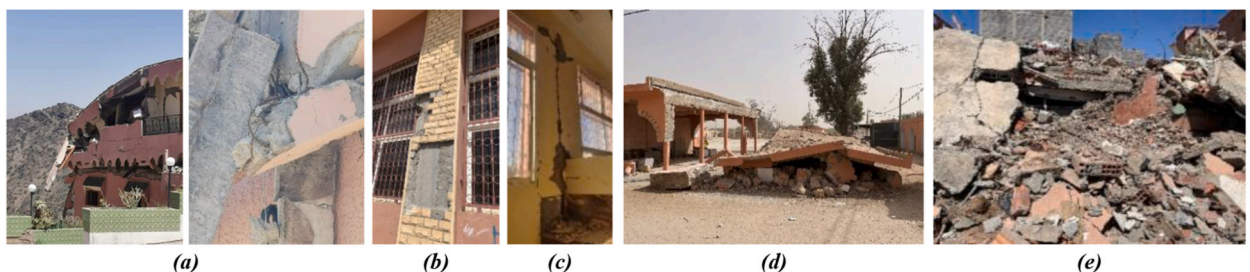
**Fig. 32.** (a) Four–storey RC hotel exhibiting a soft–storey collapse; (b–c) three–storey RC frame hotel showing external and internal non–structural damage; (d) RC frame commercial building with full collapse, while the adjacent structure remains intact due to sufficient lateral stiffness; (e) RC frame commercial building showing total collapse with debris indicating poor reinforcement detailing and inadequate confinement.

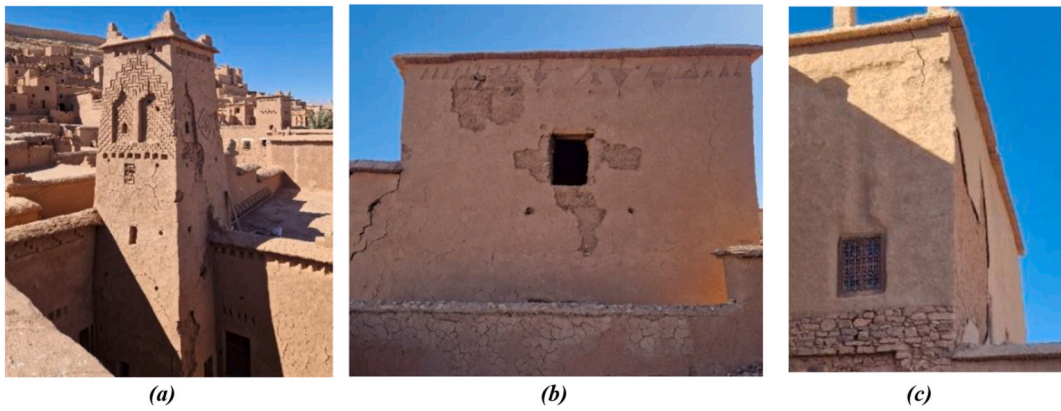
Fig. 36. Ait Ben Haddou: (a–c) Spalling of earthen render around corners and openings.

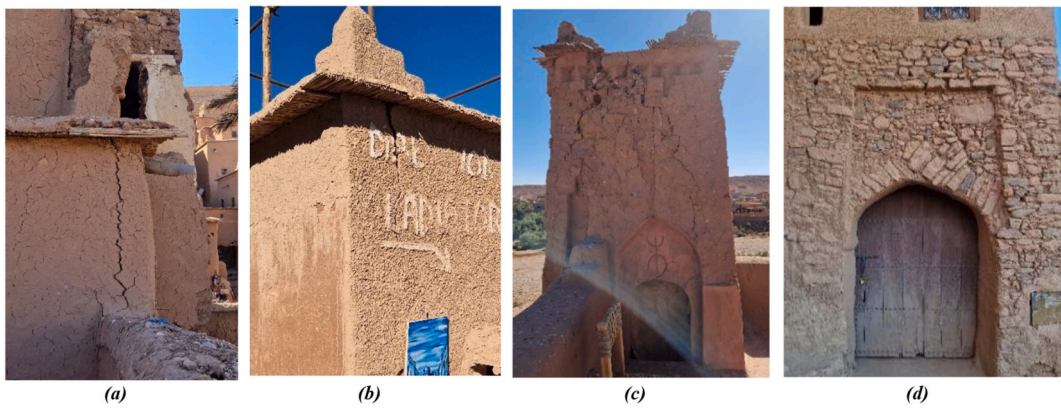
Fig. 37. Ait Ben Haddou: (a–b) Corner separation cracks indicating out-of-planes failure (c–d) diagonal shear cracks to openings.

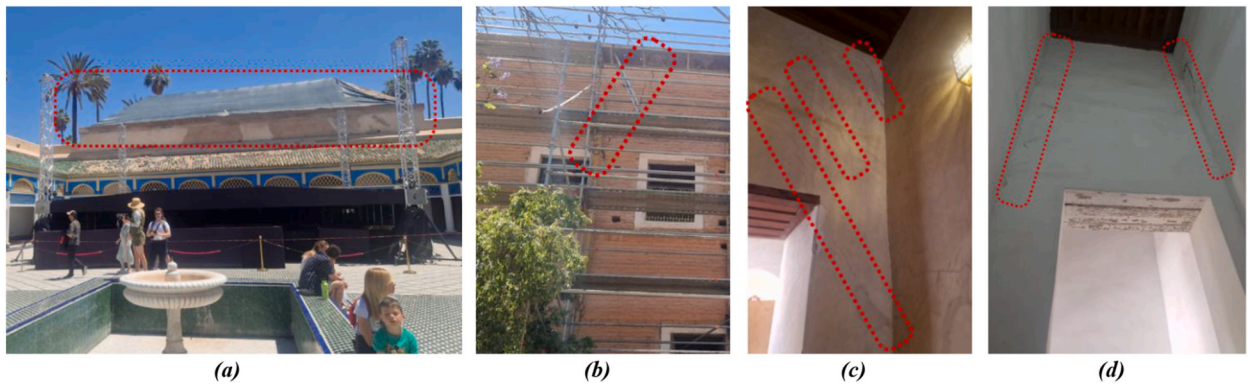
**Fig. 39.** Bahia Palace: (a) failure of roof of large pavilion at the Courtyard of Honour; (b–c) diagonal shear cracks at various locations; (d) corner cracks at top of walls.

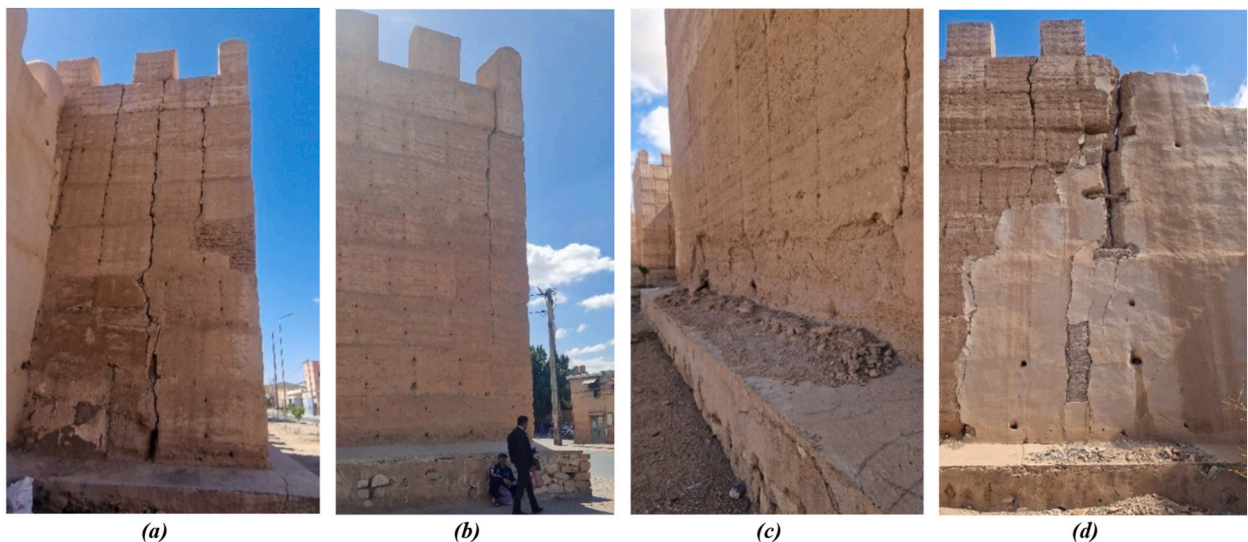
**Fig. 40.** Taroudant city wall: (a–b) vertical cracks at or near corners; (c) toe crushing at the wall base; (d) reopening of past crack repairs.

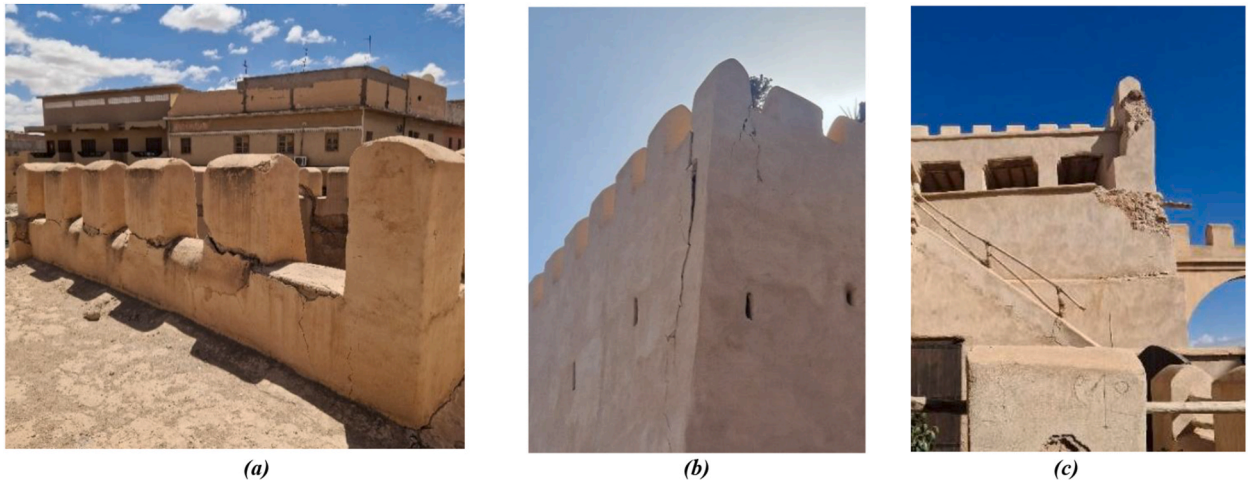
**Fig. 41.** Babs of Taroudant city wall: (a) out-of-plane cracks at the base of merlons at Bab Targhount; (b) vertical corner cracks at Bab Ouled Bonouna; (c) partial collapse at the top of the wall at Bab Ouled Bonouna.

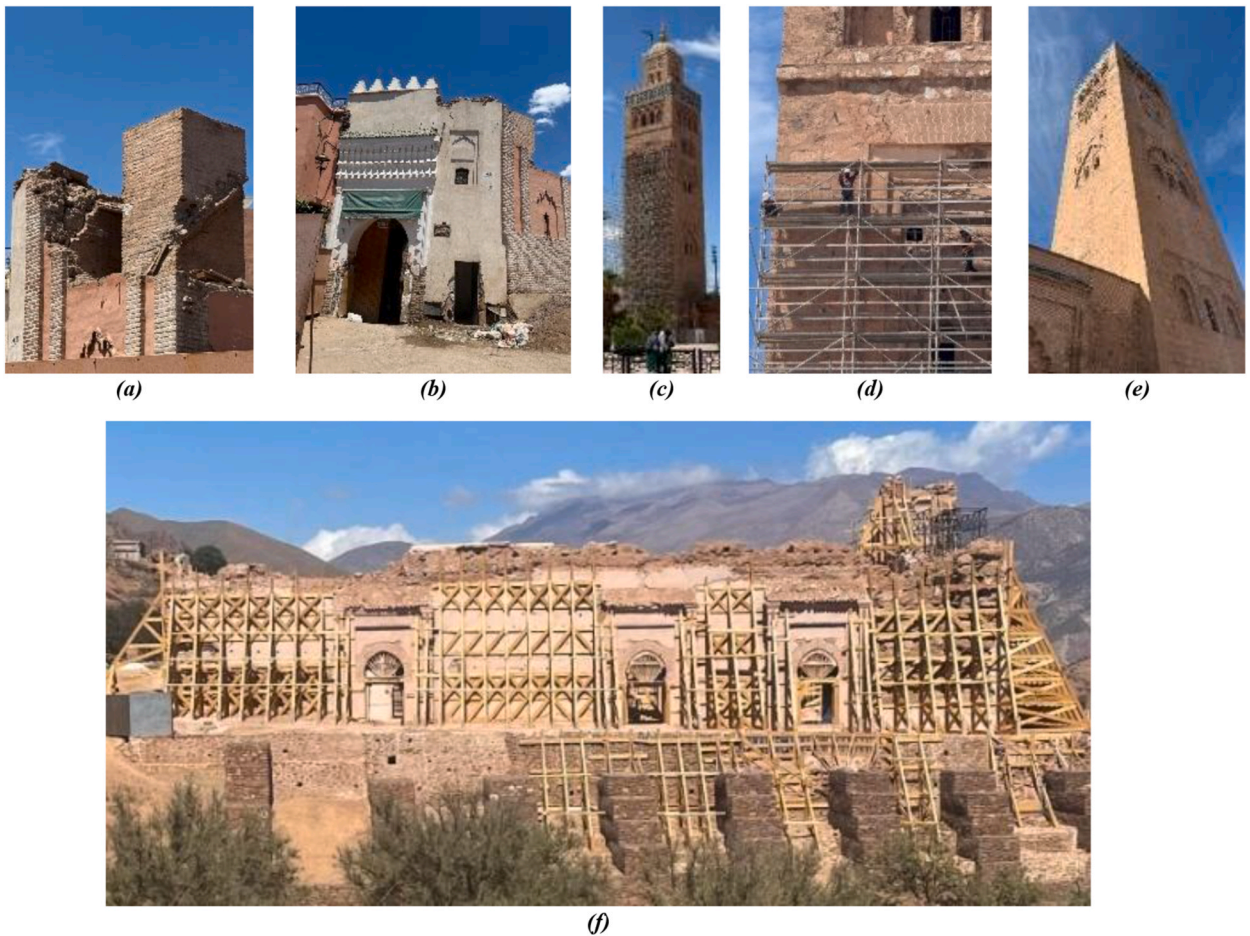
**Fig. 42.** Historic mosques affected by the 2023 Al Haouz earthquake: (a–b) Kharbouch Mosque inspected during the EEFIT mission in 2024 and during a follow-up visit in December 2025; (c–d) Koutoubia Mosque inspected during the EEFIT mission in 2024; (e) conservation interventions observed on the Koutoubia minaret in December 2025; (f) Tinmel Mosque showing extensive temporary interventions.
