# The 2023 $M_w$ 6.8 Al Haouz, Morocco earthquake: A multi-layer reconnaissance framework for the remote sensing and field assessment of landslides, building and heritage damage, and road access disruption in the High Atlas region

presents findings from the Earthquake Engineering Field Investigation Team (EEFIT) mission. Different radar and optical remote sensing techniques were used to identify areas most affected by earthquake-induced landslides and building damage, guiding the field investigations. A total of 2671 earthquake-induced landslides were identified; although relatively limited for an event of this magnitude, they significantly impacted road accessibility and emergency response. In parallel, 455 buildings were assessed on site and classified using the EMS-98 scale. Seismic performance was primarily influenced by construction practices and detailing rather than structural typology. Traditional unreinforced masonry buildings exhibited the highest vulnerability, largely due to substandard materials and construction practices, and limited upkeep, which are common in remote villages. Hybrid constructions combining traditional and modern techniques also performed poorly. Co

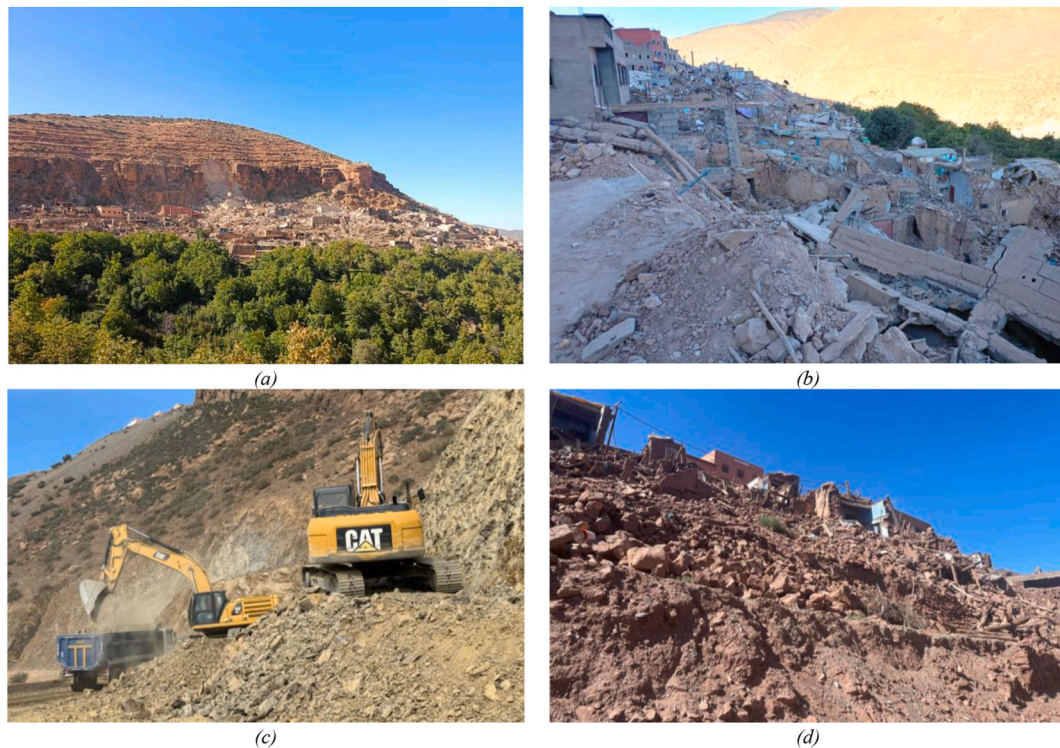
**Fig. 2.** Earthquake impacts in the High Atlas region: (a) overview of Imi N'Tala Al Haouz Province (High Atlas Mountains), showing a typical mountain settlement with dense construction along steep slopes; (b) extensive collapse of residential buildings in Imi N'Tala, constructed with non-engineered techniques in remote communities; (c) earthquake-triggered rockfalls and landslides along the Tizi N'Test corridor, obstructing mountain roads and requiring clearance operations; and (d) collapse of hillside dwellings in Talat N'Yaaqoub, illustrating the interaction between steep terrain and structural vulnerability.

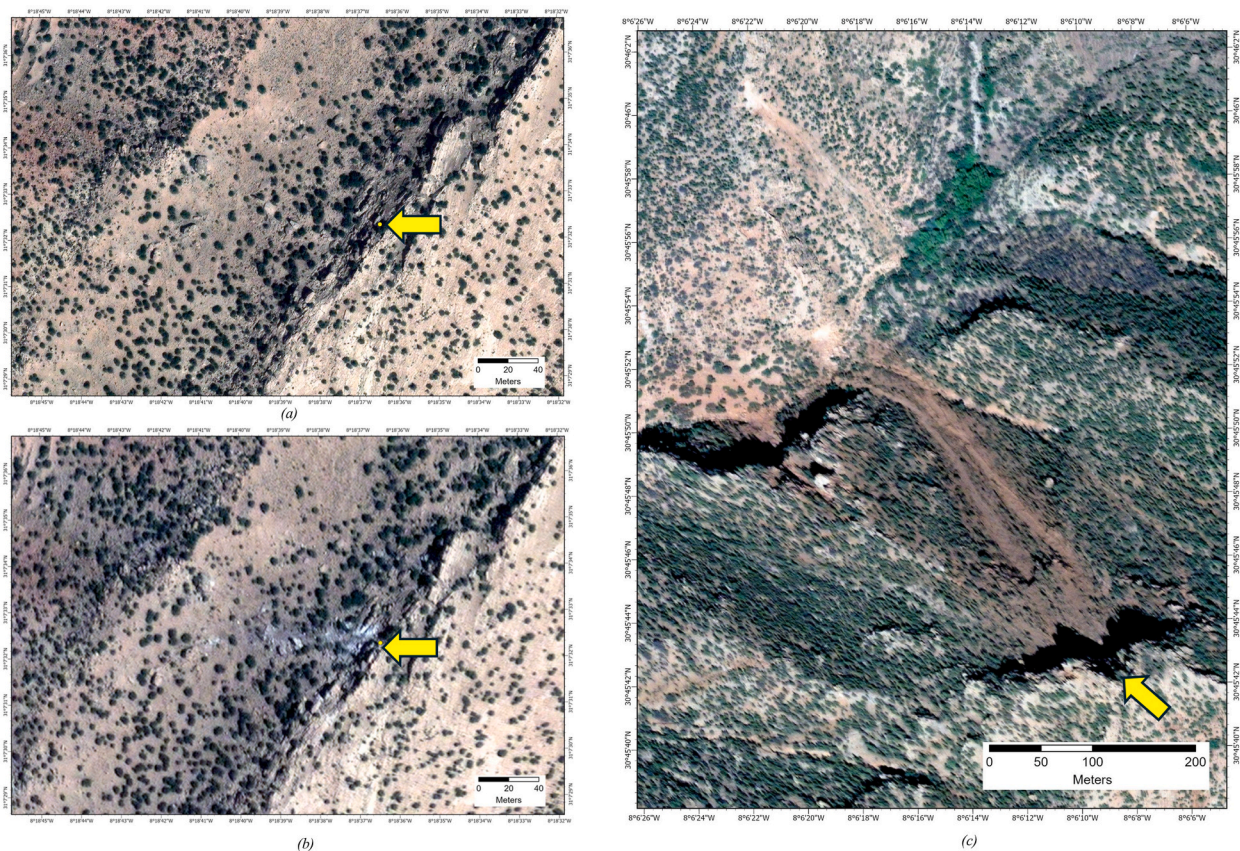
**Fig. 5.** Maxar satellite image examples of rockfalls triggered by the September 2023 Al Haouz earthquake. (a–b) Pre- and post-event imagery illustrating a typical, difficult-to-identify small-scale cliff failure in Mesozoic limestone. (c) Rare large-scale cliff failure rockfall of Mesozoic limestone with long runoff.

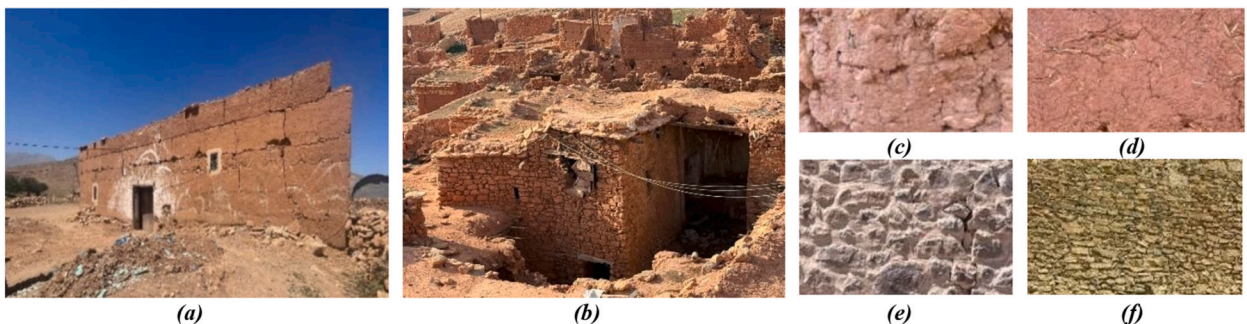
**Fig. 17.** URM typologies (a) RE; and (b) SM. Construction details: (c) RE with gravels and small pebbles; (d) RE with straw; (e) rounded SM; and (f) flat SM.

URM typologies (Fig. 17a and b) represent the predominant traditional building stock in the surveyed settlements and exhibited the highest proportion of severe damage within the EEFIT dataset (Fig. 11c and d). The most severe damage occurred in villages located near the epicentre (Fig. 1), where strong ground shaking intensity and possible local site amplification effects were reported [82–85]. The following section first describes the material and construction characteristics of URM typologies, including wall and roof systems, and then links these to the global seismic failure mechanisms observed in the field.

Within the surveyed URM buildings, 57% were constructed using load bearing RE walls, compacted in situ within formwork and typically incorporating gravel, small pebbles, and straw (Fig. 17c and d). These structures are built on elevated stone plinths to mitigate the impact of ground water and rising damp [18–25]. RE construction relies on layered compaction within formwork, making material quality and interlayer bonding critical to structural integrity [86,87]. Evidence of poor compaction and weak cohesion in RE buildings was observed, leading to vertical cracking along construction joints in approximately 20% of cases (Fig. 17a). Partial abandonment and irregular maintenance further exacerbated material degradation.

The remaining URM stock consisted of load-bearing SM walls constructed with irregular, rounded, or flat granite or limestone stones (Fig. 17e and f). SM buildings were historically associated with more affluent households due to higher construction costs compared to RE [88–90]. SM walls typically comprise two stone leaves enclosing a cavity filled with loosely bonded rubble and low-quality mortar (Fig. 18a). Consistent with typical multi-leaf masonry behaviour under lateral loads [91–93], SM walls exhibited material loss (Fig. 18b) and leaf separation (Fig. 18c and d). These material-level damage mechanisms, when combined with roof hammering in the direction of seismic loads, often lead to out-of-plane arch-type failures at the wall crest (Fig. 18e–g), ranging from partial material loss to complete collapse.

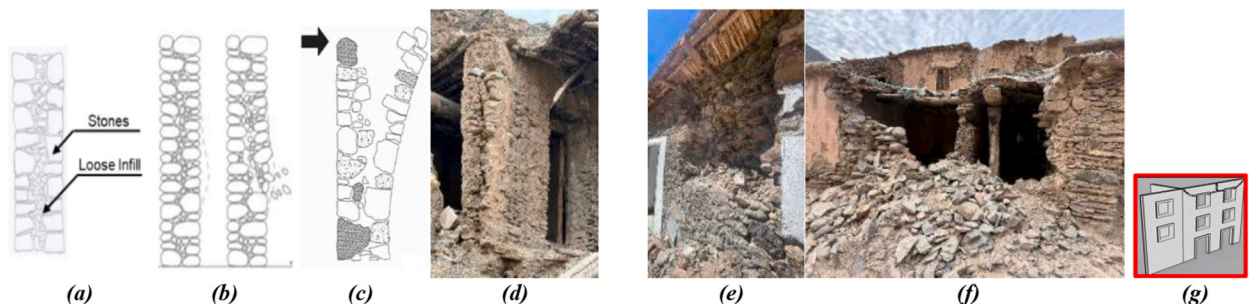
**Fig. 18.** (a) Schematic of a multi-leaf SM wall, modified from Ref. [91]; (b) schematic of leaf separation due to material loss, modified from Ref. [92] (c) schematic of leaf separation due to roof hammering, modified from Ref. [93]; (d) leaf separation; (e) severe and (f) complete collapse due to arch-type failure. (g) Arch failure mode sketches adapted from Ref. [94].

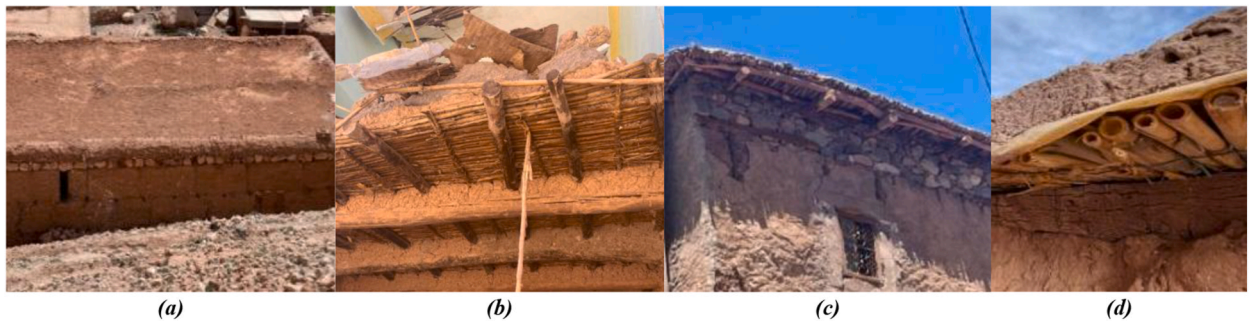
**Fig. 19.** Timber floor/roof system: (a) timber roof with compacted mud; (b) primary beams with secondary branch elements; (c) stone layer beneath the roof at the wall crest; (d) primary beams with secondary bamboo canes.

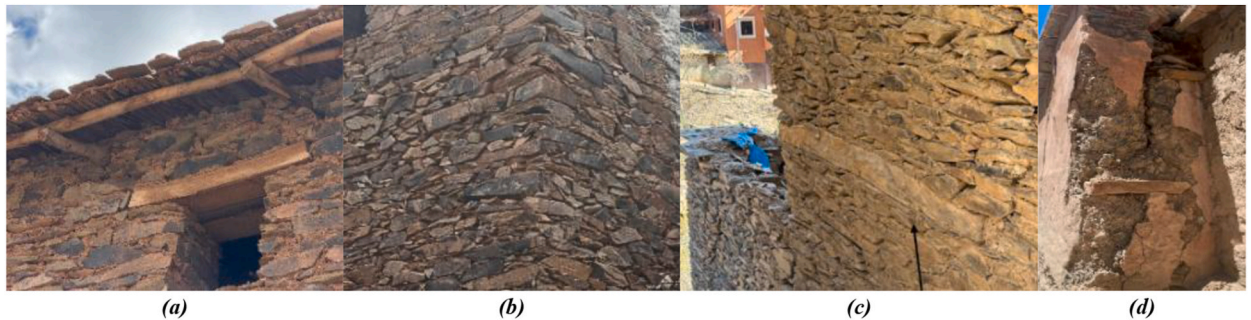
**Fig. 23.** (a) Timber lintels above openings; (b) cornerstones enhancing interlocking; (c) timber stitches/dowels within the wall; (d) timber dowels at corners.

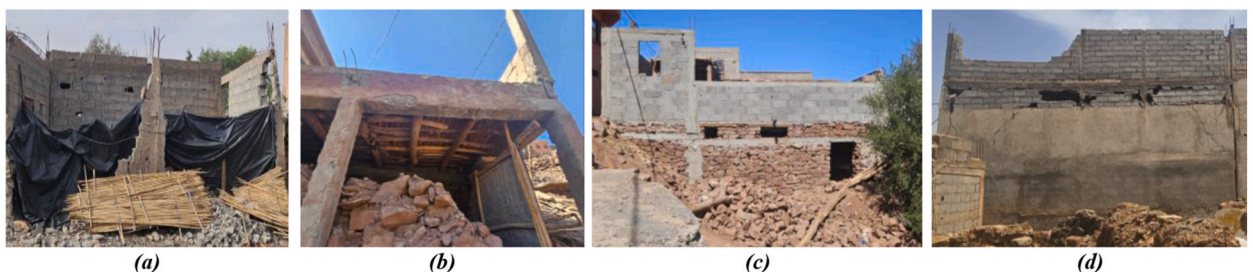
**Fig. 25.** Temporary shelter: (a) Confined Masonry (CM) with Concrete Masonry Units (CMU) panels without first-floor slab; (b) CM with stone masonry (SM) panels with traditional floor. Intermediate Housing: (c) CM with SM panels with a reinforced concrete (RC) sill band enclosing short CMU, (d) CM with CMU panels without the sill band.

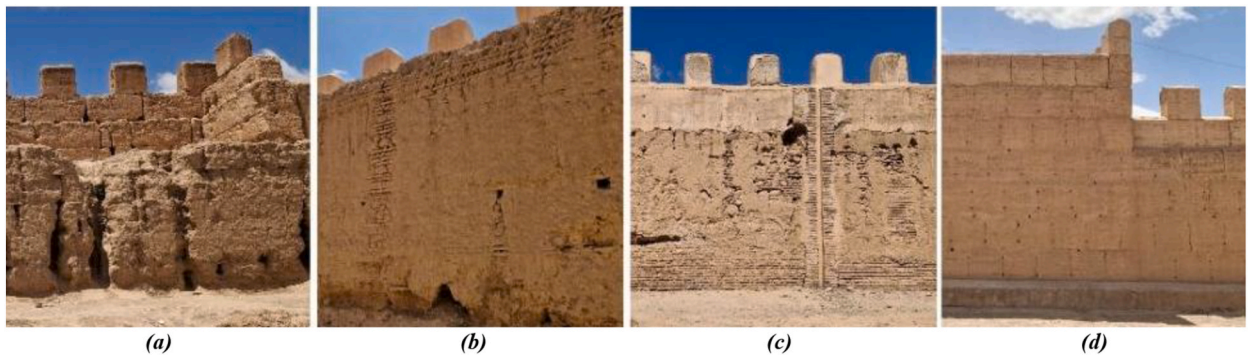
In several locations, earlier restoration interventions using compatible materials were evident, such as previous repairs along the Taroudant city wall (Fig. 34). In some cases, post-earthquake repairs had already begun during the EEFIT mission, including crack stitching with timber poles embedded in earthen mortar at Kasbah Taourirt (Fig. 35). The conservation approach applied to monumental architecture contrasts with the more limited and often ad hoc maintenance practices observed in residential buildings constructed with traditional materials. Although some URM structures incorporate traditional mitigation measures such as timber ties, dowels, or cornerstones (Fig. 21e and 23), these elements were often irregularly implemented or poorly anchored, limiting their effectiveness.

**Fig. 34.** Diverse states of conservation and past restoration interventions along the city wall of Taroudant.

heterogeneous conservation conditions along its length due to repairs undertaken during different historical periods (Fig. 34).
